## When Kildwick Church nearly fell down – and what was done to save it

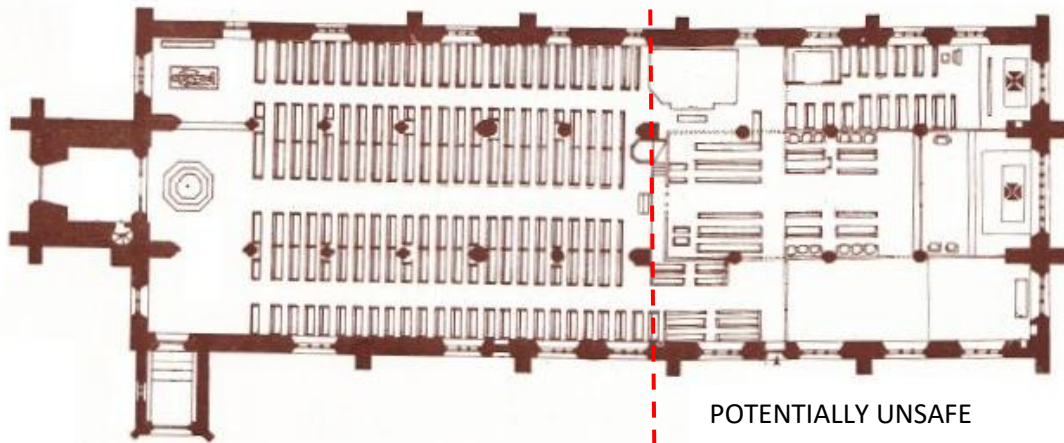
By the end of May 1897, the architect had reported back. It was not good news. He recommended that "No part of the Church east of the pulpit should be used until restored".

Area of the church thought unsafe – as of May 1897

Mr Peterson, architect, Bradford, reported upon a recent examination of the fabric. He stated that three bays of the choir were 6in. out of the perpendicular. The centre pillar of the south aisle was considerably damaged, and this fixture was not only insecure in itself and dangerous to the public, but was also an eyesore. He considered that the north and south arcades should be rebuilt, and that the roof of the church should be reslated. He estimated the cost at about £1200.—The Vicar said that they believed the total alterations needed would mean an outlay of about £1400 or £1500.—Mr F P Peacock, a warden, said that they had no funds with which to face the outlay, and were, in fact, £20 in arrear at the end of the last financial year.

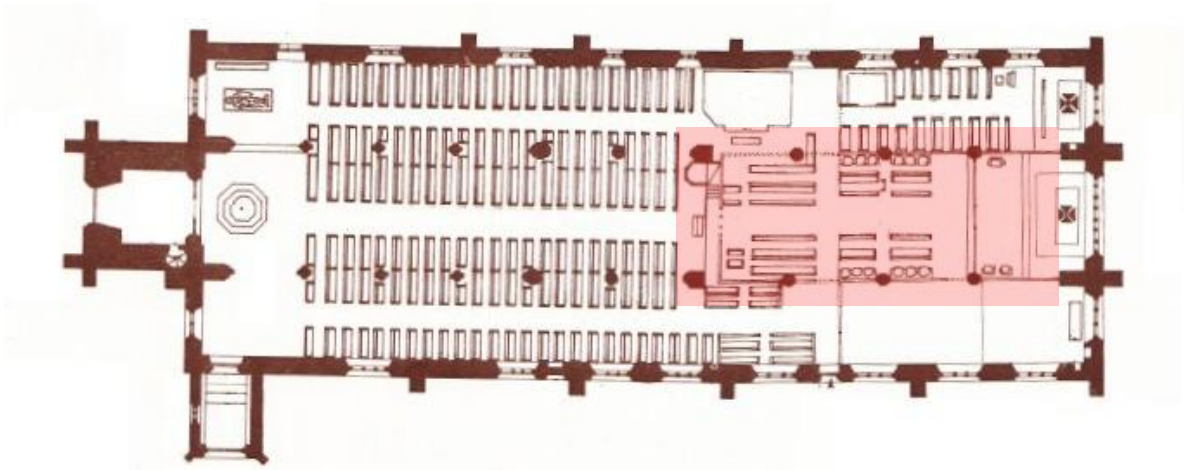
This extended the area requiring attention further west than the original plan and a recommendation was made for the immediate propping-up of the pillar to the west of the organ. The cost of the restoration work would increase by 20%.

**Area of the church thought to require attention (shaded) – as of December 1899**

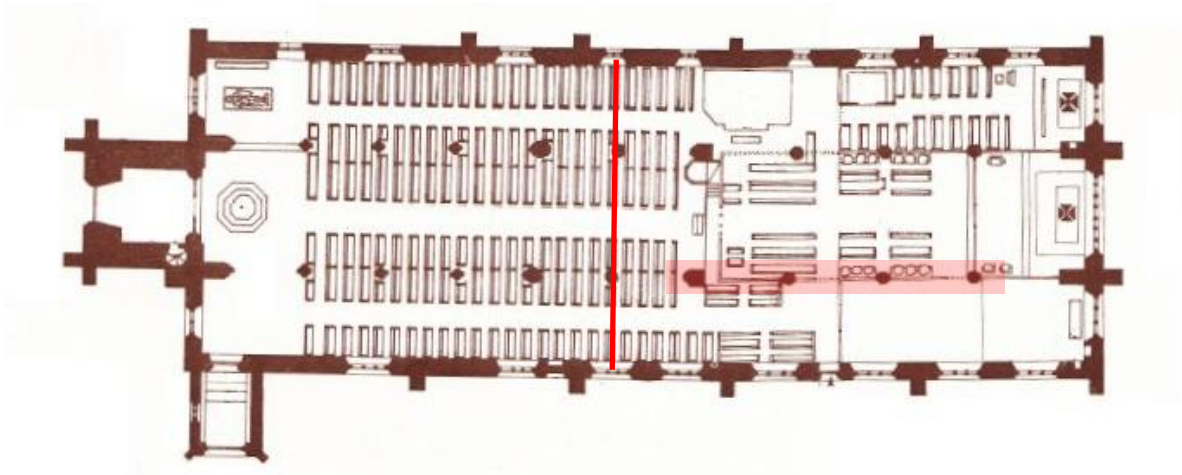
**Location of the protective partition (red) – 25/11/1901 to 20/9/1902  
and the work carried out in December 1901 and January 1902 (shaded)**

On December 2nd, the plaster was stripped off the four arches and pillars on the south side that had been previously been propped – shown shaded above. Cracks were found in a number of the pillars and arches, with one pillar cracked diagonally almost from top to bottom.

The reason why the pillars were leaning towards the south was also found. None of them had foundations and had been erected on the surface of the soil, or only a few inches beneath, and over graves which had subsequently collapsed.

All four pillars and arches, and the wall above that the arches supported were demolished. It was during this work that the wall above the arches would found to contain blocks of stone with carved scroll-work, later identified as being fragments of Saxon (actually Anglo-Danish) crosses dating from around 950AD.

New foundations were dug for all four pillars, to a depth of six feet, and filled with concrete.

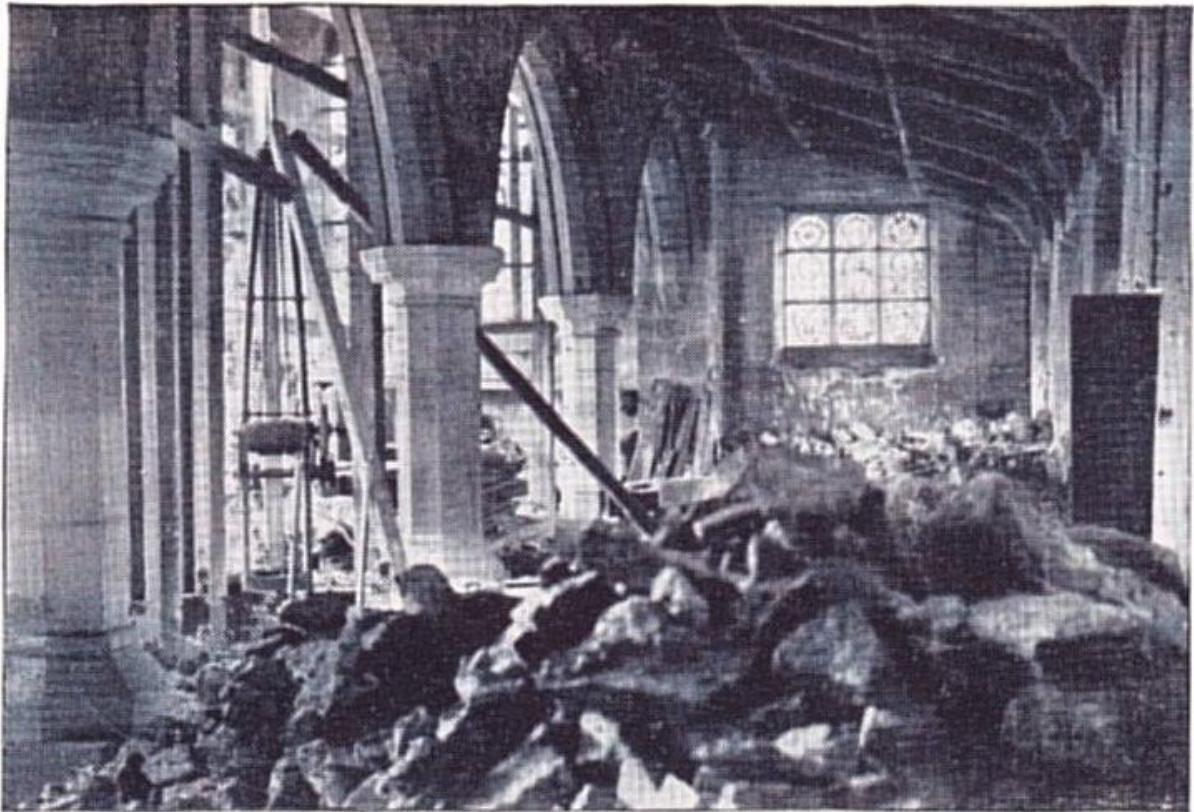
**Three of the four rebuilt pillars and arches at the south-east of the church**

Once the foundation stones were laid the pillars, arches and wall was rebuilt using the old stones where possible and new stones where the old ones could not be re-used.

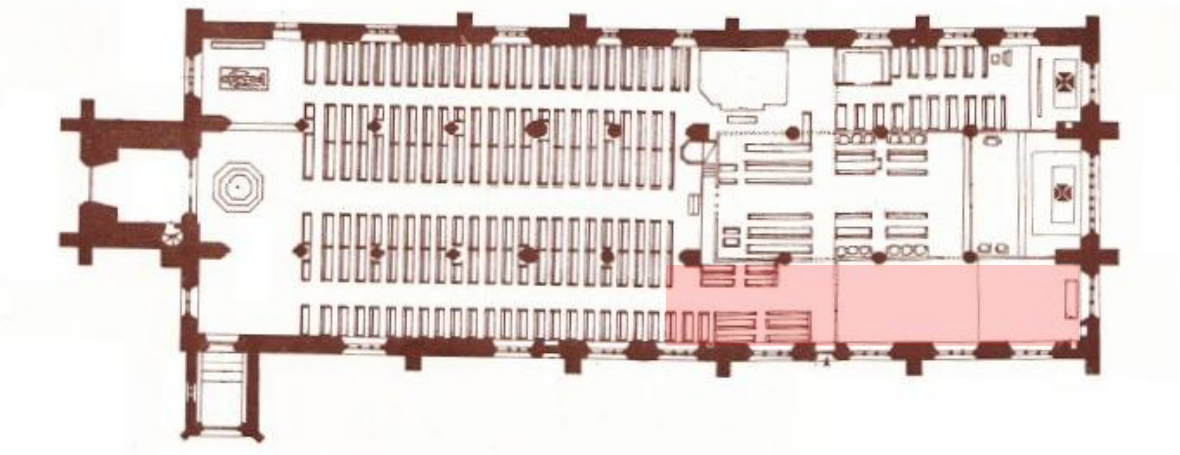
**Location of the work carried out on the roof and inside of the south wall  
in February and March 1902 (shaded)**

It was found that the spars holding up the roof of the single-storey south aisle were rotten and needed to be replaced.

This work involved removing the existing plaster on the inside of the south wall. It had been hoped to then just re-point the stonework, however it was found that the size and quality of the stones did not allow re-pointing, and the wall would need to be re-plastered.

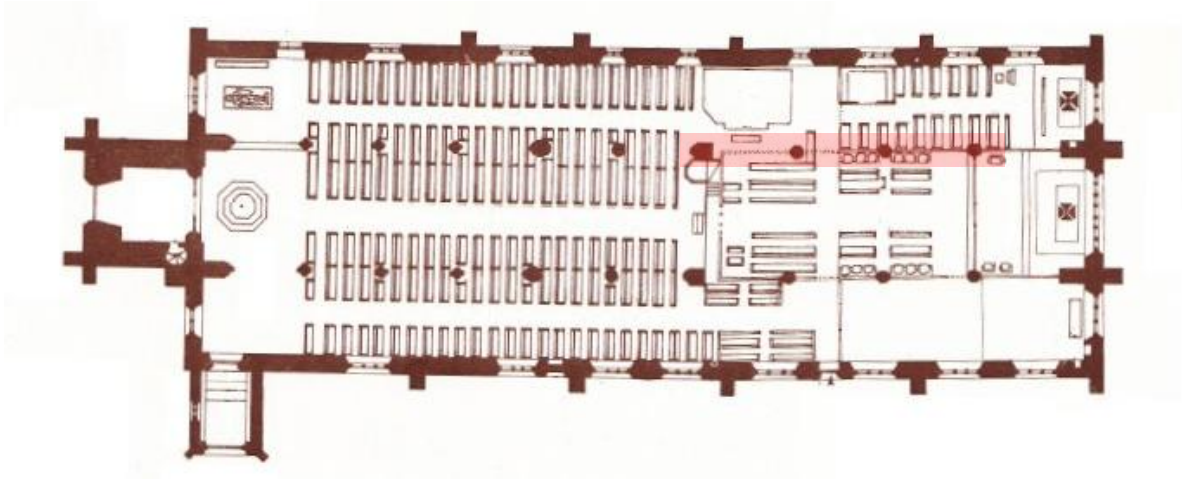
**Location of work carried out on the north side pillars  
in March and April 1902 (shaded)**

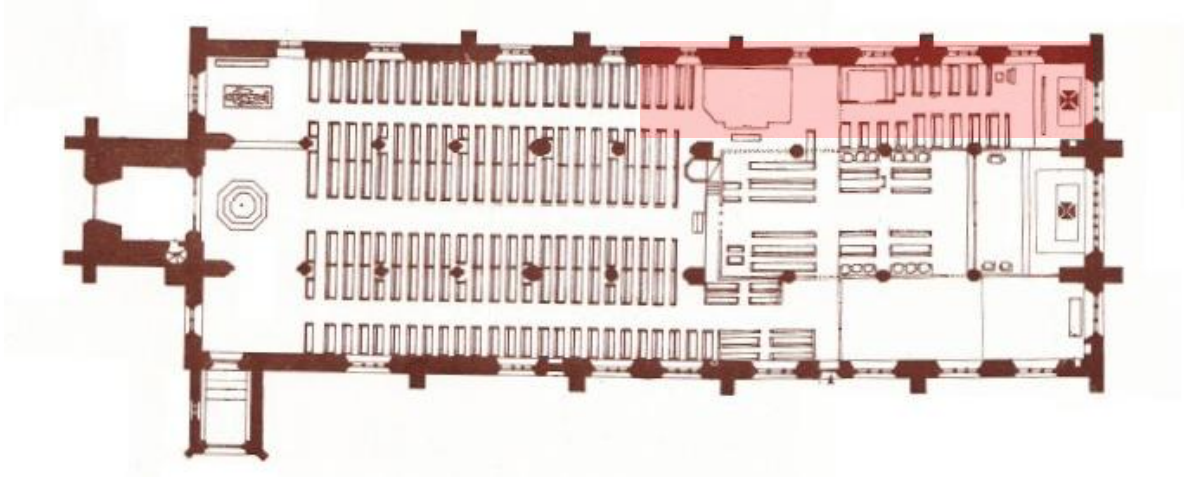
This reordering of the chapel turned out to be rather fortuitous as it was quickly found that part of the north wall of the chapel – the exterior wall of the building – was leaning inwards.

**Location of work carried out on the north side of the building during May and June 1902 (shaded)**

The roof was removed and the external wall taken down. Here again it was found that this wall had no foundations, having been built directly on the ground surface.

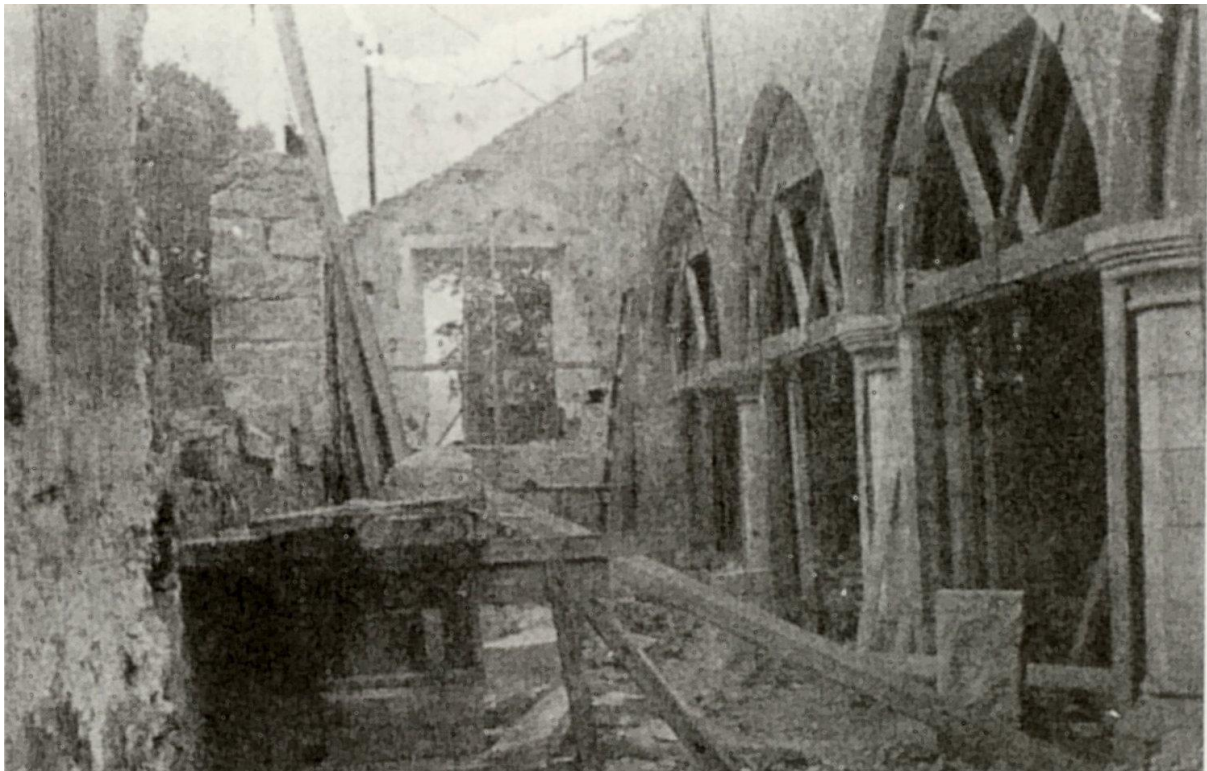
**Curren Chapel, looking east, without a roof and with part of the north wall taken down (June 1902)**

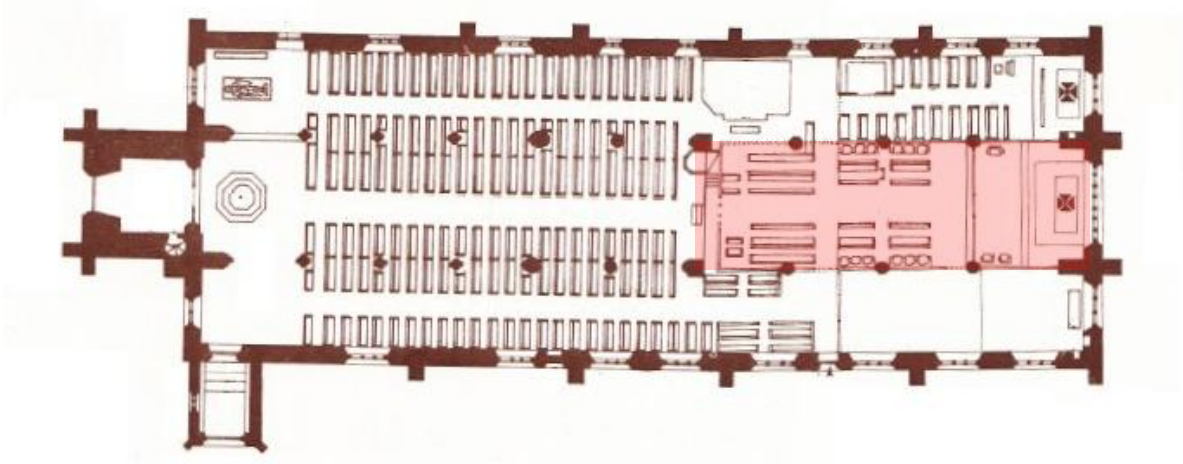
**The re-positioning of the central section of the roof on the rebuilt pillars and arches (July 1902)**

Work on the pillars and arches had corrected their lean to the south and made them perpendicular. During this work the roof of the central section had been held up with props. It was now time to realign the roof and fix it to the newly repaired walls.

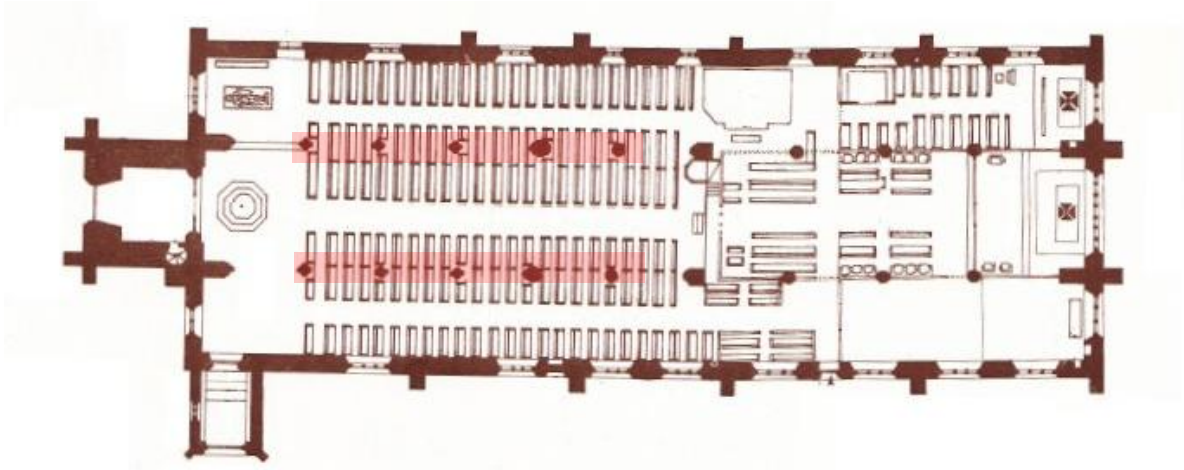
**Location of work carried out on the pillars of the west end during Autumn and Winter 1902 (shaded)**

Removal of the plaster showed the poor condition of many of the pillars:

- North side, pillar four (from west end): built largely from rubble
- South side, pillar four: ditto
- North side, pillar five: missing most of the base, which had been cut-away
