## When Kildwick Church nearly fell down – and what was done to save it

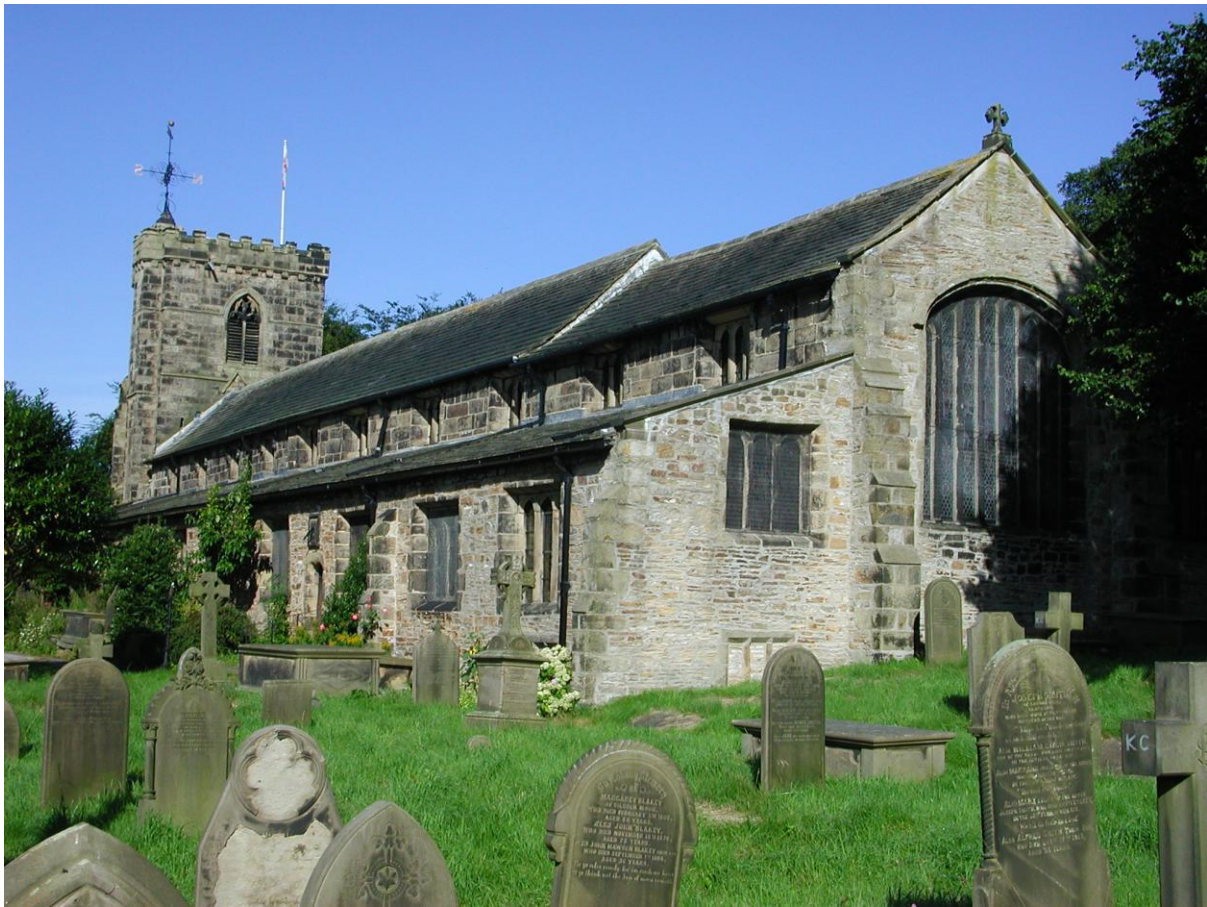
**Exterior of Kildwick Church, showing the south side of the building.  
The clear “break” in the roof-line indicates the start of the Tudor extension.**

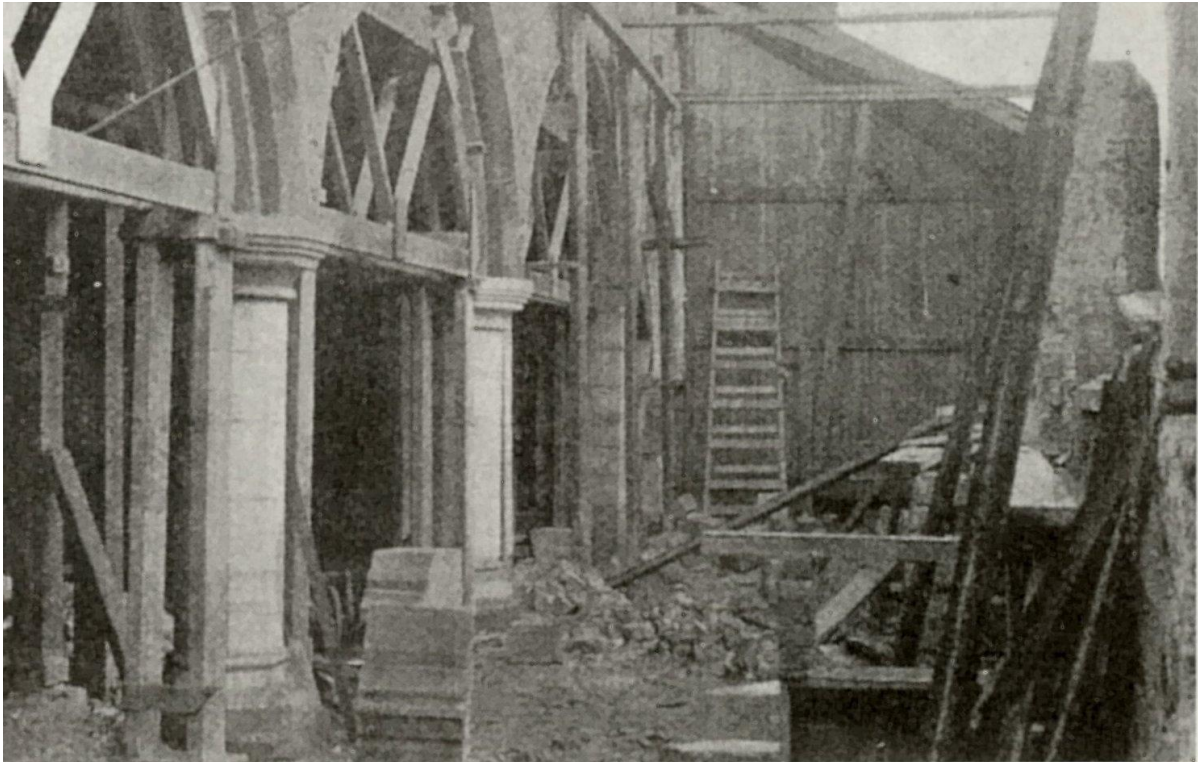
This reordering of the chapel turned out to be rather fortuitous as it was quickly found that part of the north wall of the chapel – the exterior wall of the building – was leaning inwards.

The roof was removed and the external wall taken down. Here again it was found that this wall had no foundations, having been built directly on the ground surface.

**Work in progress on the north side of the building, looking west.  
The back of the partition built across the church can be seen.**

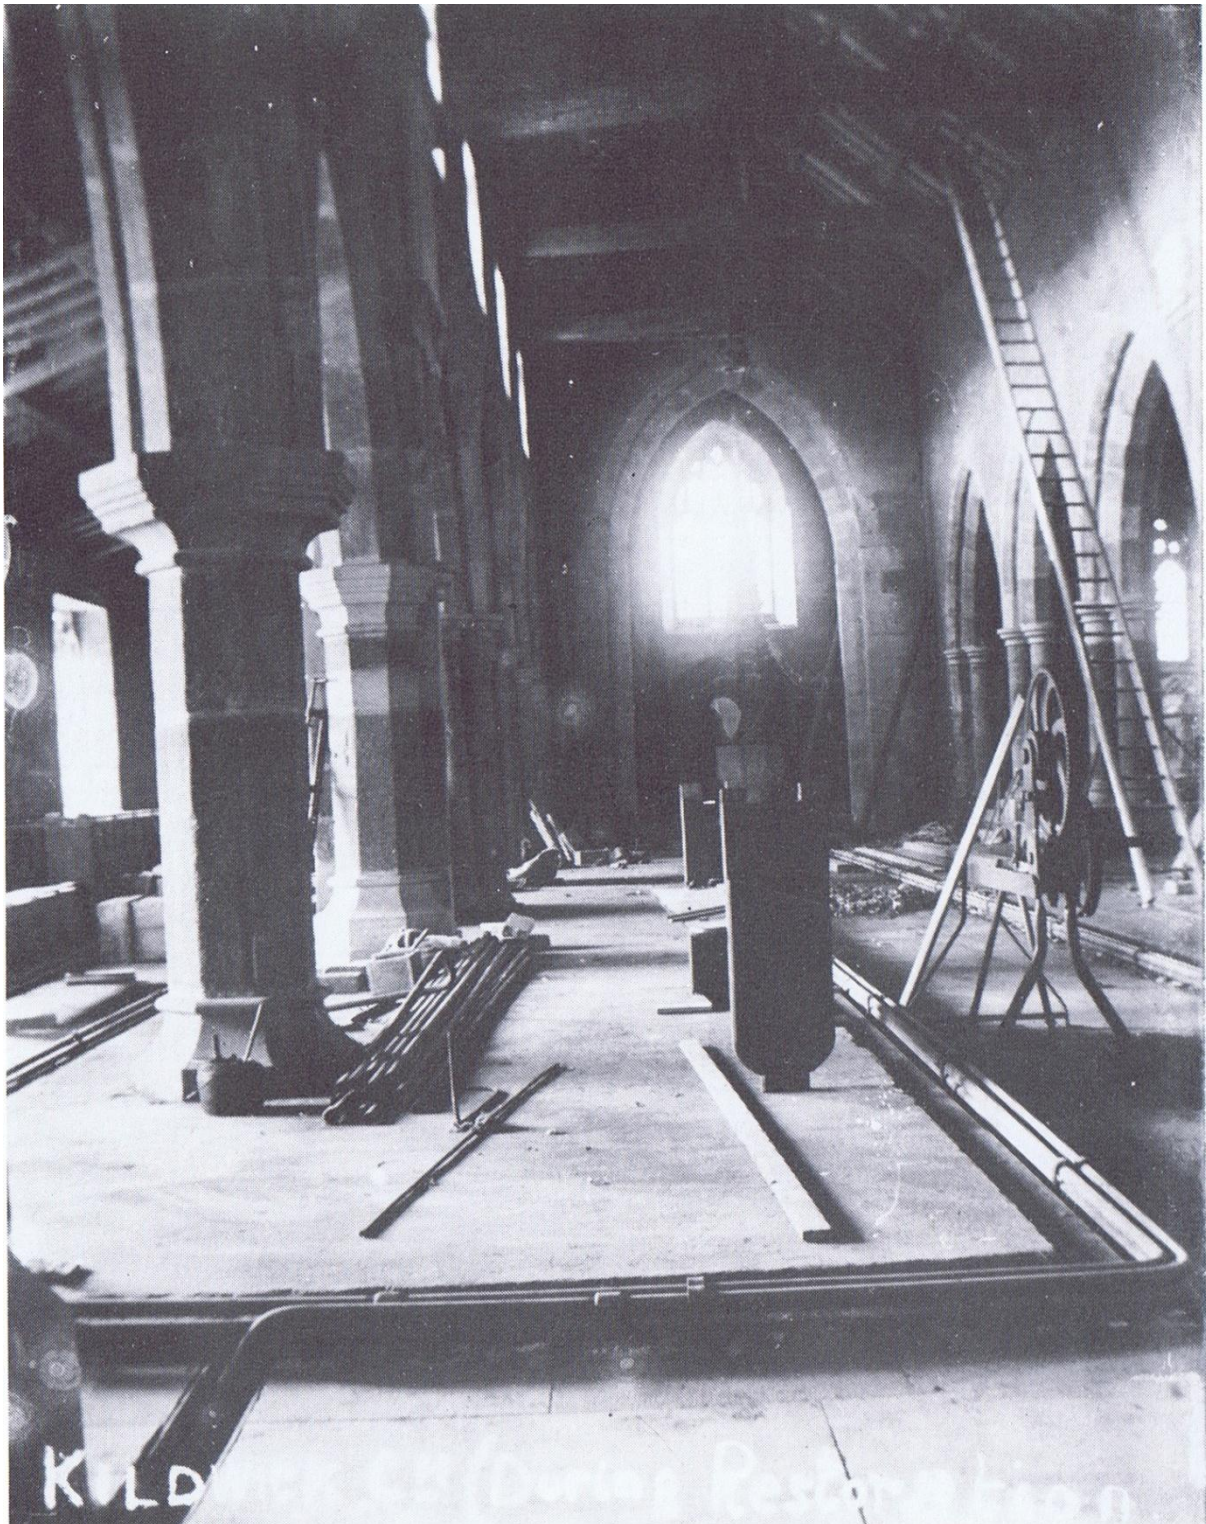
**Work in progress at the west end of the church (Autumn/Winter 1902  
Notice the opened-up west end of the church, all the pipe-work, and the new masonry**
