The Kildwick Rail Crash of 1875

Part 4 – Why was the crash so bad ?

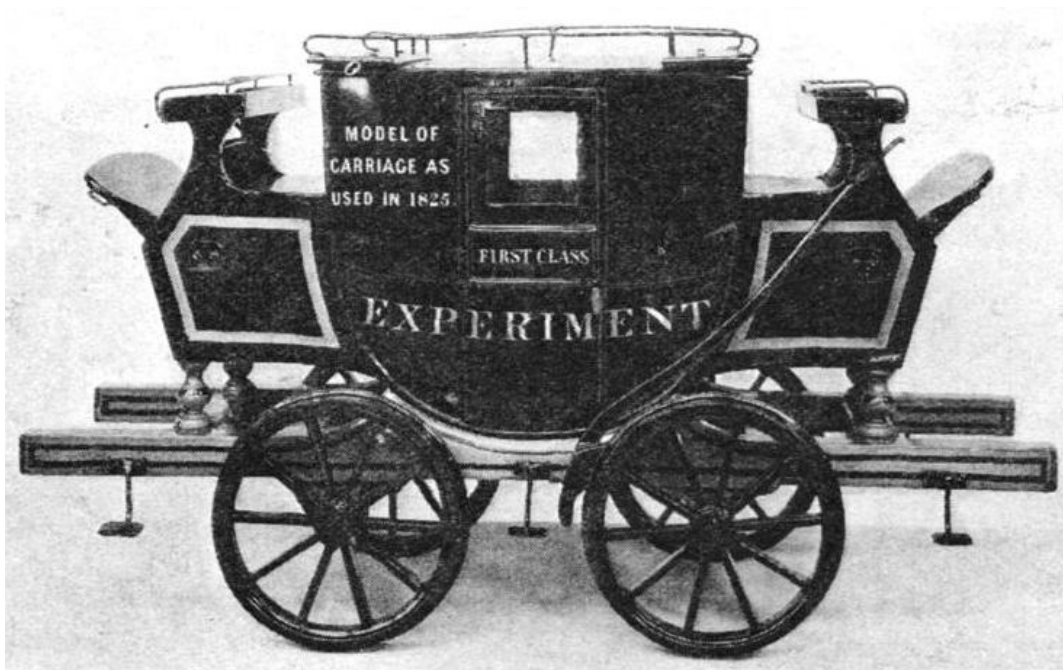
Fig 1: The “Experiment”, the first passenger railway carriage, came into service on the Darlington-Stockton line just a fortnight after the first passenger rail journey, in October 1825.

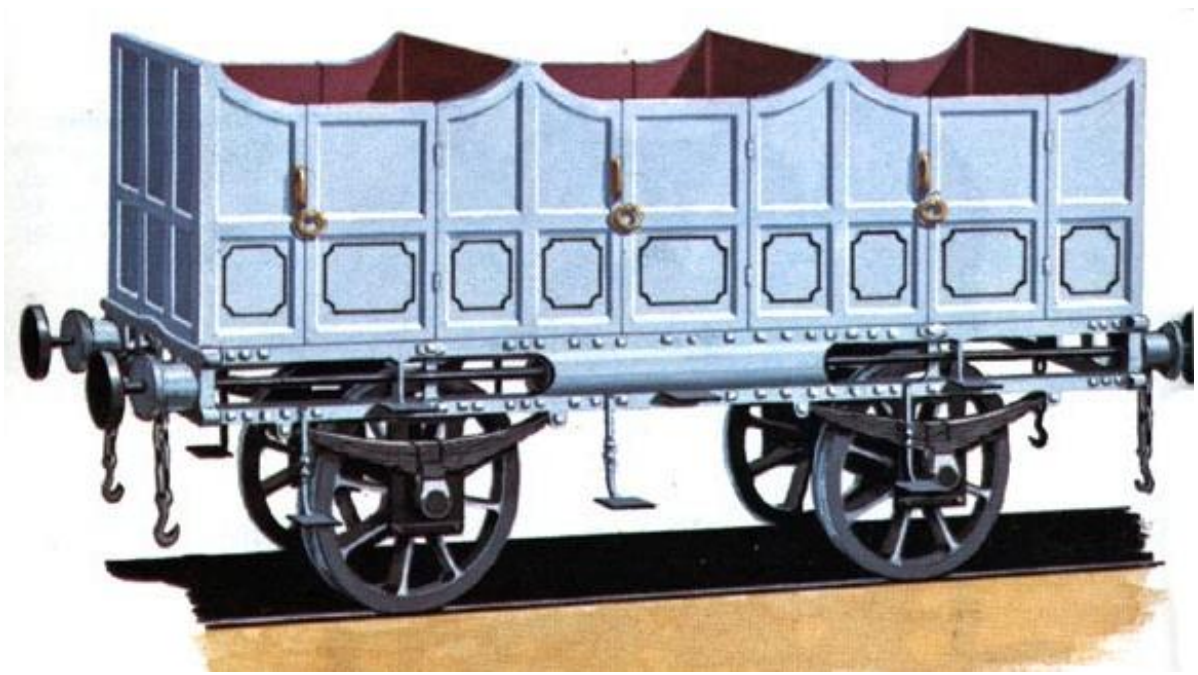
Fig 2: No, this isn't a freight truck, it's a third-class carriage from the Liverpool-Manchester railway c.1830.

By the late-1830s a three-class system had become the norm for all new and existing railway companies, even though third-class carriages were not necessarily attached to each train. First-class passengers always had the best accommodation, their compartments containing soft furnishings and window glazing. Initially, second-class carriages had roofs and padded seats, but were usually still open to the elements on either side; however, this latter feature did become less common up to the 1860s. Lastly, third-class passengers travelled in little more than open trucks with wooden seats.
