The Kildwick Rail Crash of 1875

Part 2 – Inquests, inquiries and reports

Introduction

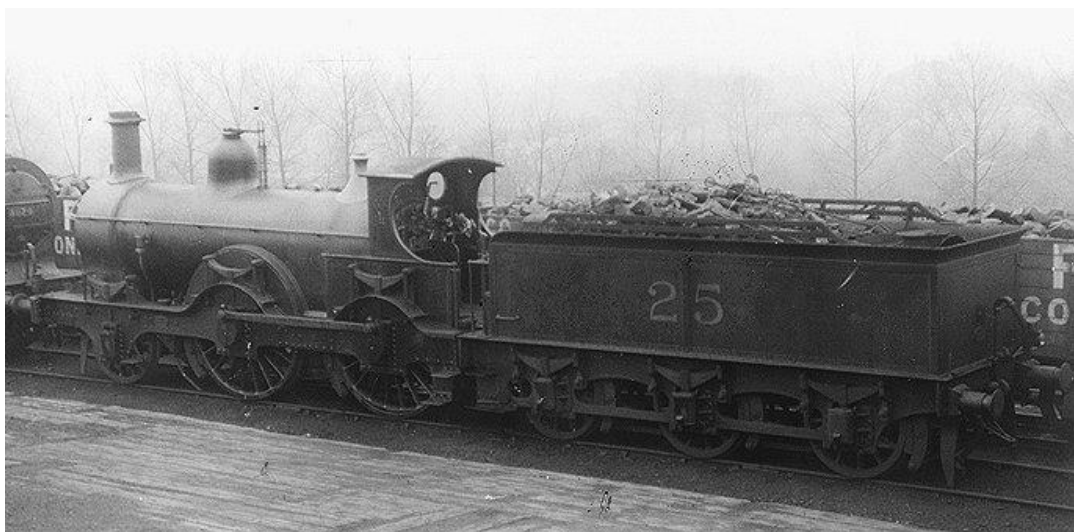
Fig 2: Midland Railways' locomotive no. 825, one of the same class of locomotives as that involved in the Kildwick crash. No. 819 was pulling the mail train; no. 814 was used by Capt. Tyler in his stopping-distance tests.

So it was that on September 27th 1875, 50 years to the day since the very first passenger train ran between Darlington and Stockton, a series of four stopping-distance tests were carried out on the Midland Railway's Derby-Castle Donnington-Trent line; in bright weather with slightly greasy rails.

The results of these tests showed that a train travelling at 50 mph could be stopped in around 800 yards (the actual results for the four tests – using various combinations of braking equipment – were: 807, 813, 867 and 787 yards).
